1942 Vintage API-ASME Vessel Revitalization

**Intersection of FEA, PCC-2,
and NBIC**

May 2015 CBIA Conference

Jim Riley and Matt Andrews

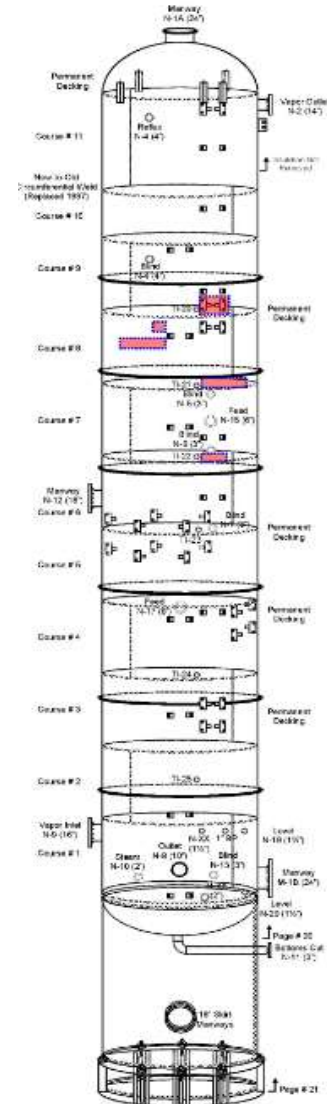
- Staged all around the tower ('ballroom'), removed insulation, and grit blasted the shell to remove scale and old paint.
- QualSpec completed automated UT (AUT) scanning doing 9.5 courses of the shell (excluded new top section replaced in 1997). API-QUTE industry-qualified UT shear wave examiner and a ASNT-TC-SC1 Level II shearwave qualified technician.

- QualSpec used manual UT for nozzles, manways, and locations where AUT was not possible (support clips, ladders, etc...)
- O-U inspector working with QualSpec AUT scan data created a 3-D layout with corrosion thickness bands for the shell sections.

- Included lowest readings in the band and average thickness range in the band.
 - This data was the basis for the FEA model and areas where weld repair would be required.

- Manual UT used to confirm lowest reading locations and mark them on the shell. Identified 4 weld repair areas, ~14 sq. ft of surface
- O-U inspector used an NDE crew to UT-grid the skirt corrosion which was similar to a 'moon crater' surface.

- The lowest thickness found was used for the skirt FEA. The foundation, anchor chairs and anchor bolts were in good condition.
